## Cargo Airplane Strikes Building During Rejected Takeoff

*The accident report said that an engine malfunction may have occurred at a critical time during the Douglas C-54A-DC's takeoff, that the flight crew used inadequate procedures during the rejected takeoff and that the first officer was impaired by medications.*

—  
*FSF Editorial Staff*

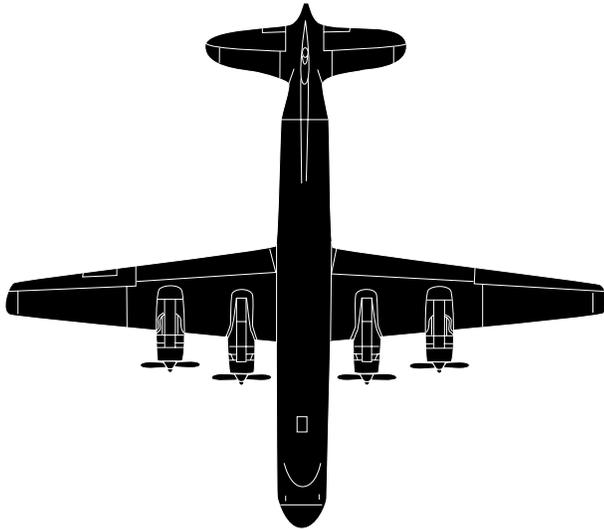
## Aviation Traders ATL.98 Carvair

Aviation Traders — a British company that repaired, designed and manufactured aircraft — developed the ATL.98 Carvair modification of the Douglas DC-4 (U.S. military designation C-54) in 1961.

The modification involved the installation of a larger nose section with an elevated flight deck and a vertically hinged door to accommodate the loading of automobiles and other heavy cargo, and the installation of a larger vertical stabilizer and rudder.

The airplane has four 1,450-horsepower (1,081-kilowatt) Pratt & Whitney R-2000-7M2 Twin Wasp radial engines and three-blade Hamilton Standard propellers. Empty weight is 41,365 pounds (18,763 kilograms). Maximum takeoff weight is 73,800 pounds (33,476 kilograms). Rate of climb at sea level is 650 feet (198 meters) per minute.
