FLIGHT SAFETY FOUNDATION

Accident Prevention

July–August 1997

Preparing for Last-minute Runway Change, Boeing 757 Flight Crew Loses Situational Awareness, Resulting in Collision with Terrain

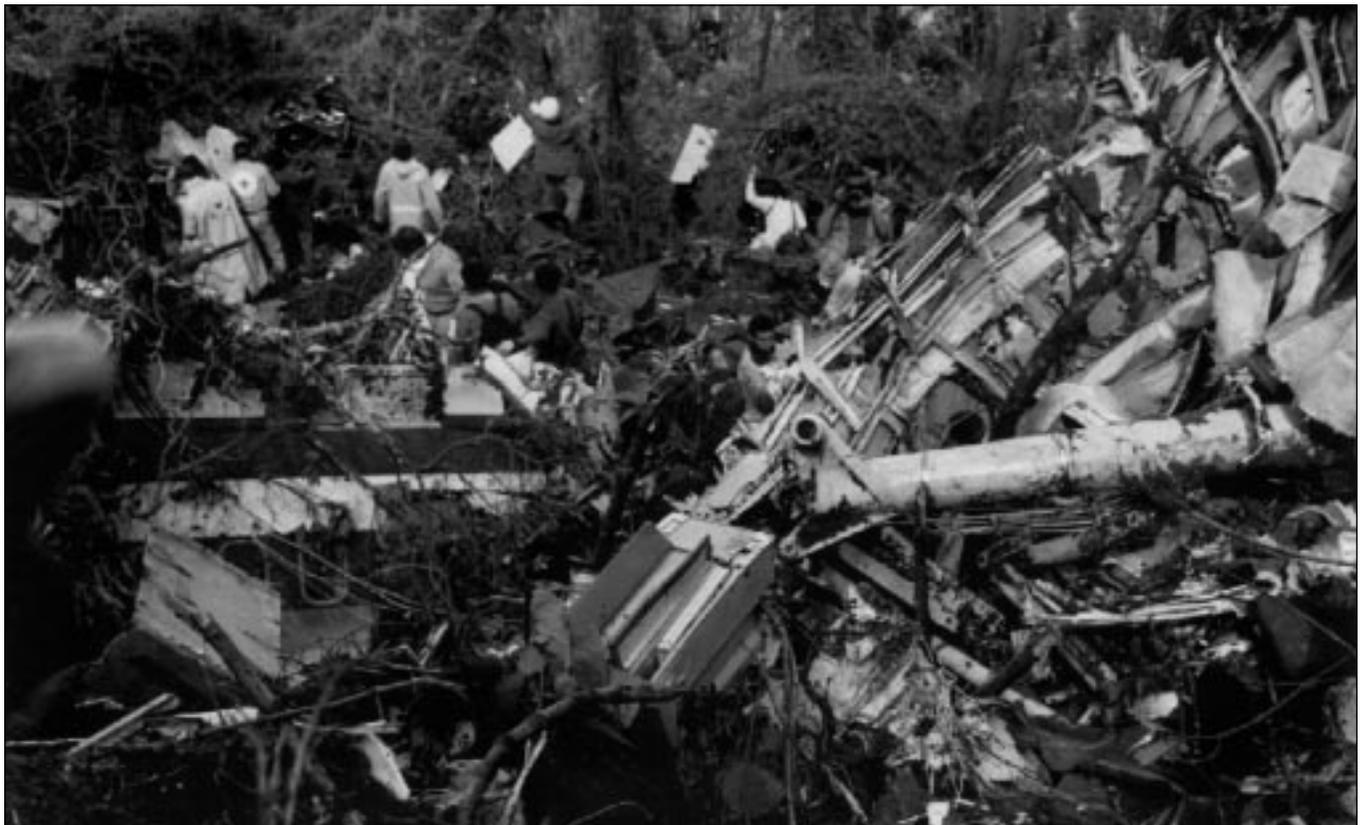
After the aircraft struck trees on the east side of a mountain ridge, the main wreckage of Flight 965 came to rest on the west side about 122 meters to 152 meters (400 feet to 500 feet) from the top. (Photo: Reuters/Claudia Daut/Archive Photos)

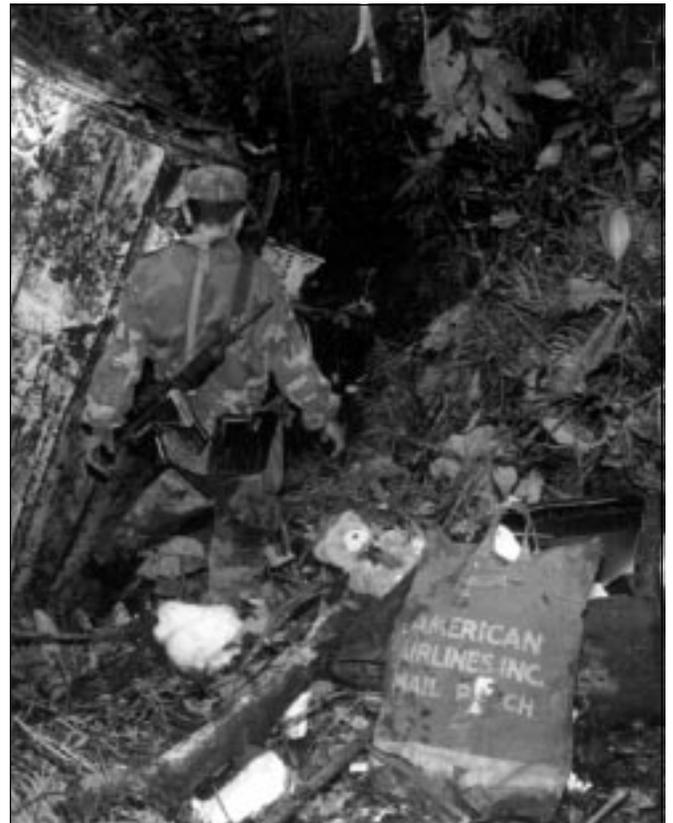
Search and rescue personnel were notified that Flight 965 was missing at 2150 hours, but it was not until after the wreckage was sighted at 0630 the next morning that search teams reached the site by helicopter. (Photo: Reuters/Henry Romero/Archive Photos)
