Chemical Oxygen Generator Activates in Cargo Compartment of DC-9, Causes Intense Fire and Results in Collision with Terrain

FSF Editorial Staff

Editorial note: This article was adapted from *In-flight Fire and Impact with Terrain, ValuJet Airlines Flight 592, DC-9-32, N904VJ, Everglades, near Miami, Florida, May 11, 1996*. Report no. NTSB/AAR-97/06. The 257-page report contains figures and appendixes.

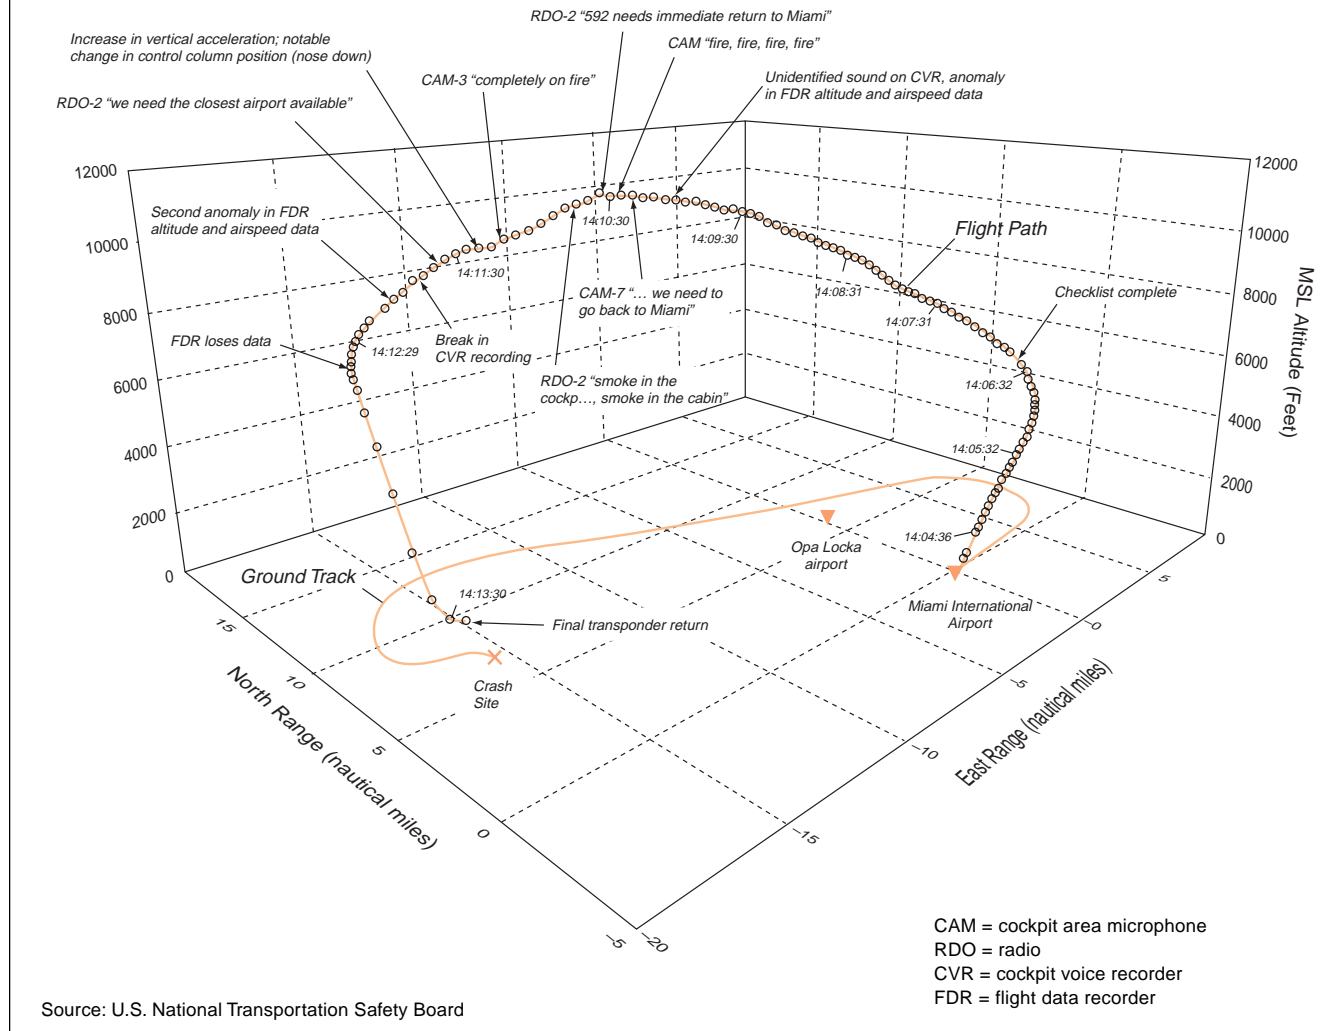
Figure 1

Flight Path of Flight 592

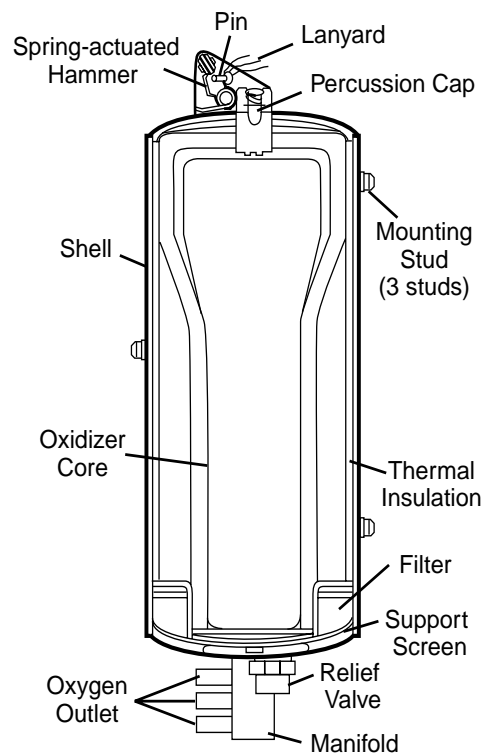
Figure 2

Chemical Oxygen Generator, Cut-away View

“The chemical reaction is exothermic, which means that it liberates heat as a by-product of the reaction. This causes the exterior surface of the oxygen generator to become very hot; the maximum temperature of the exterior surface of the oxygen generator during operation is limited by McDonnell Douglas specification to [286 degrees C] 547 degrees F when the generator is operated at an ambient temperature of [21 degrees C to 26 degrees C] 70 degrees F to 80 degrees F. Manufacturing test data indicate that when operated during tests, maximum shell temperatures typically reach [232 degrees C to 260 degrees C] 450 degrees F to 500 degrees F.

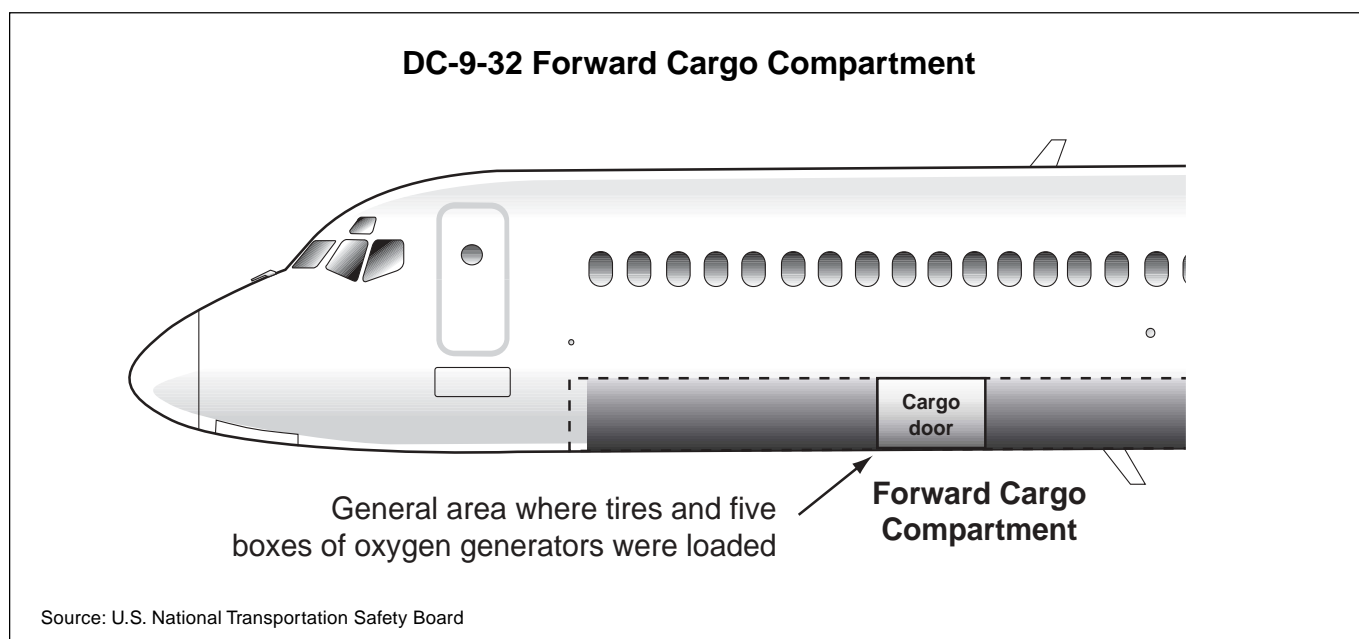
Figure 3

Investigators examined the chemical oxygen generators that were carried aboard the accident flight and recovered from the accident site. When examining the units, they discovered that: “Safety caps were not installed over the percussion caps that start a chemical reaction in the oxygen generators; lanyards for the retaining pins for the percussion caps’ spring-loaded actuation mechanism were not secured on several generators;

and the generators were not packaged adequately to prevent generators from striking the actuation mechanism or dislodging retaining pins on adjacent generators,” said the report.
