Chemical Oxygen Generator Activates in Cargo Compartment of DC-9, Causes Intense Fire and Results in Collision with Terrain

FSF Editorial Staff

The ValuJet Airlines McDonnell Douglas DC-9-32 had just departed from the Miami (Florida, U.S.) International Airport (MIA), when an intense fire erupted in the forward cargo compartment. As soon as the crew detected the fire, they immediately turned back toward MIA, but the fire burned through the aircraft's control cables and the crew was not able to maintain aircraft control. The aircraft collided with terrain about 27.4 kilometers (17 miles) northwest of MIA.

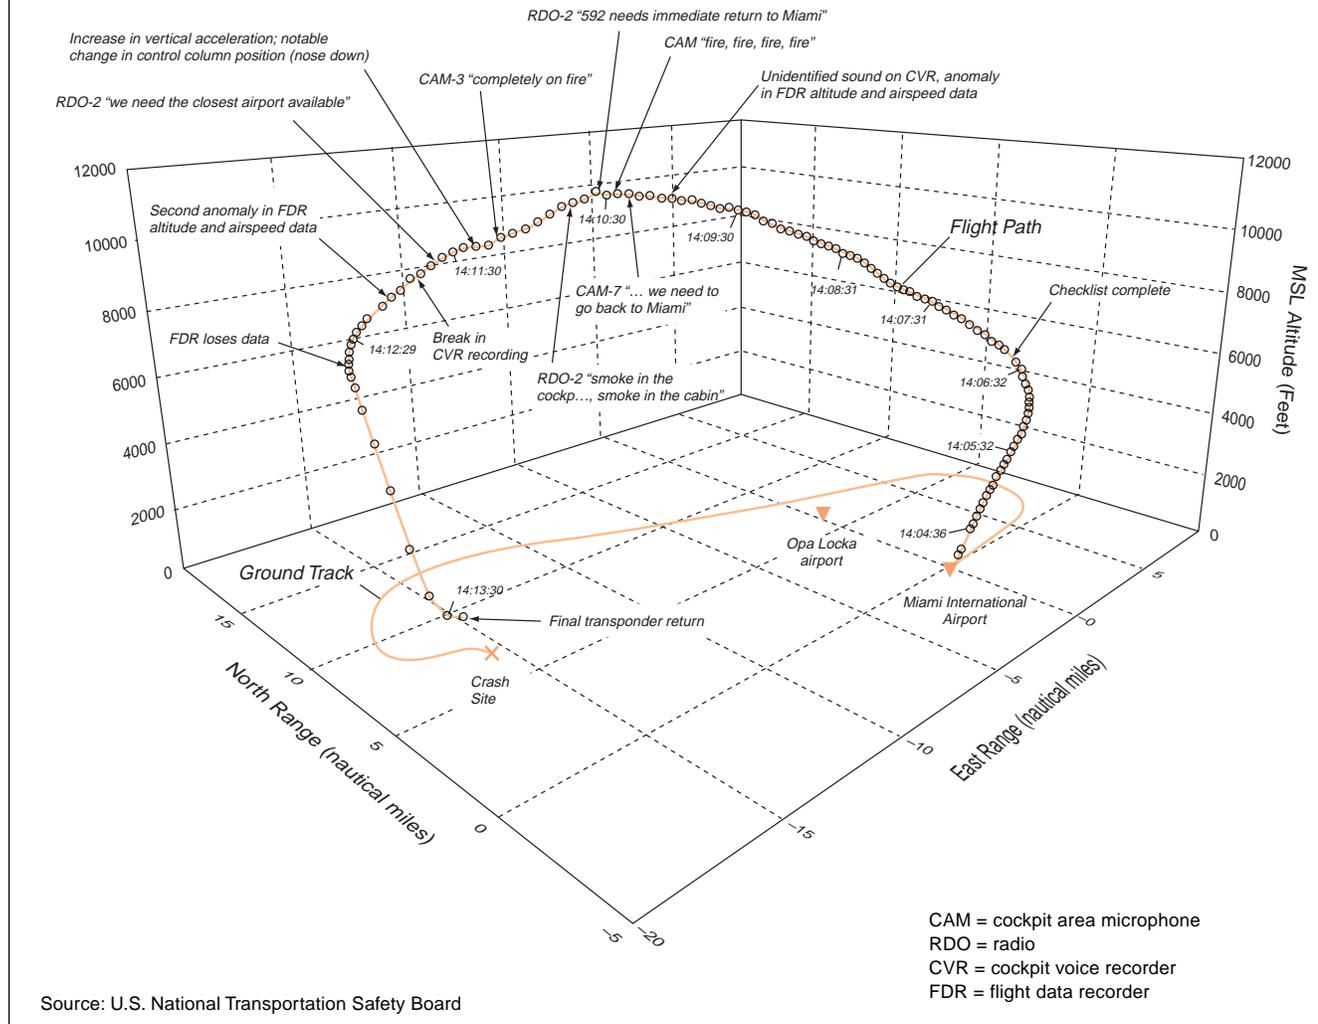
Figure 1

Flight Path of Flight 592

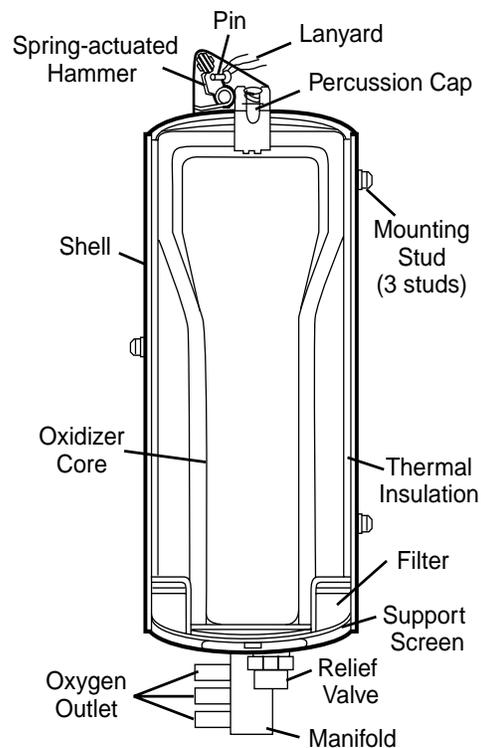
Figure 2

Chemical Oxygen Generator, Cut-away View

“The chemical reaction is exothermic, which means that it liberates heat as a by-product of the reaction. This causes the exterior surface of the oxygen generator to become very hot; the maximum temperature of the exterior surface of the oxygen generator during operation is limited by McDonnell Douglas specification to [286 degrees C] 547 degrees F when the generator is operated at an ambient temperature of [21 degrees C to 26 degrees C] 70 degrees F to 80 degrees F. Manufacturing test data indicate that when operated during tests, maximum shell temperatures typically reach [232 degrees C to 260 degrees C] 450 degrees F to 500 degrees F.

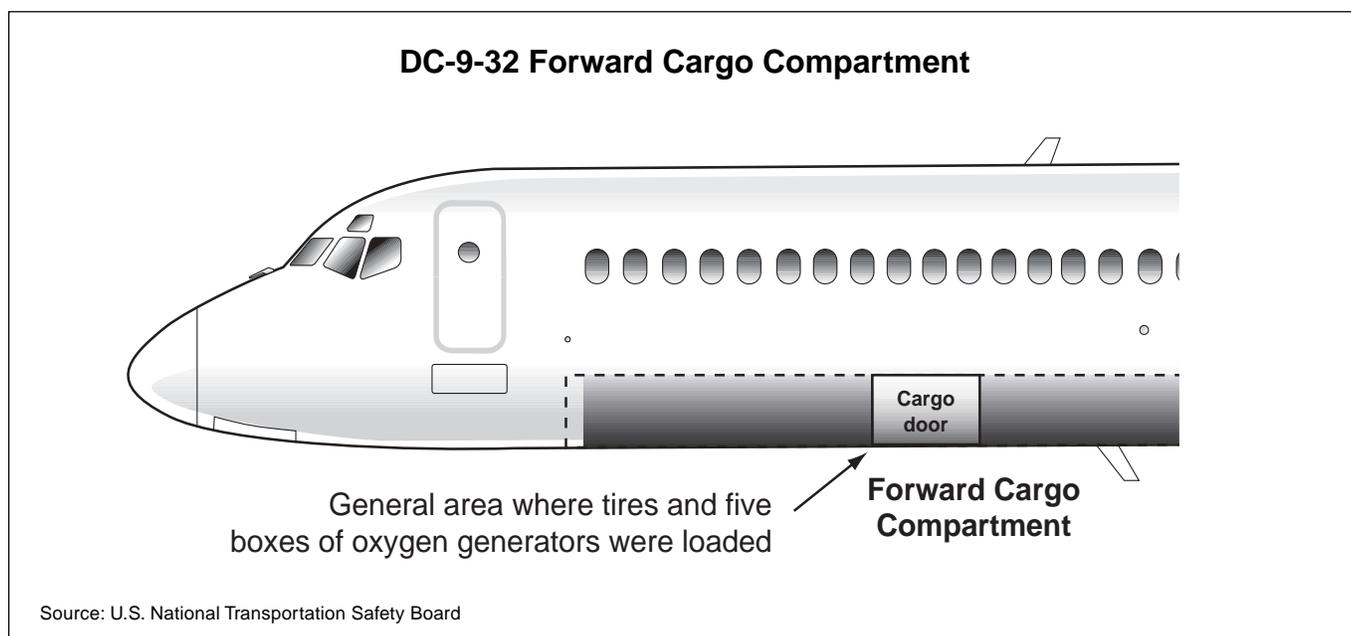
Figure 3

Investigators examined the chemical oxygen generators that were carried aboard the accident flight and recovered from the accident site. When examining the units, they discovered that: “Safety caps were not installed over the percussion caps that start a chemical reaction in the oxygen generators; lanyards for the retaining pins for the percussion caps’ spring-loaded actuation mechanism were not secured on several generators;

and the generators were not packaged adequately to prevent generators from striking the actuation mechanism or dislodging retaining pins on adjacent generators,” said the report.
