MAY-JUNE 1998

D I G E S T

Boeing 757 CFIT Accident at Cali, Colombia, Becomes Focus of Lessons Learned

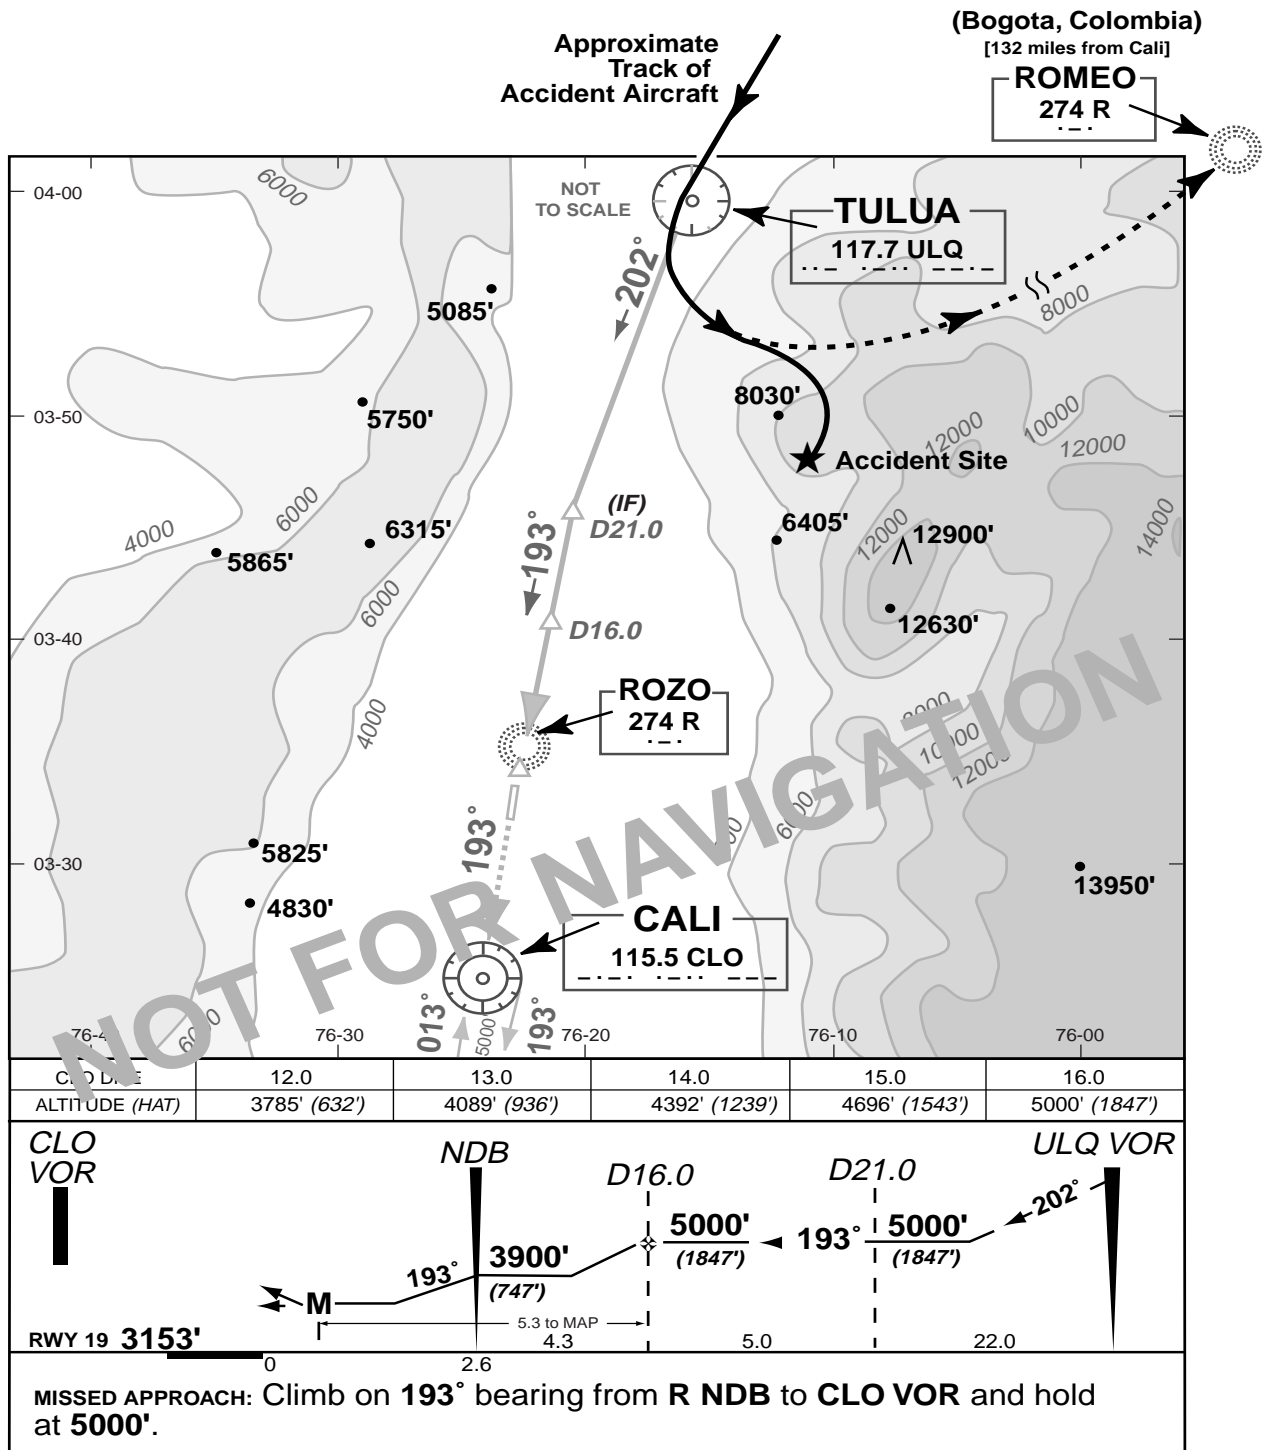
Approximate Track of Flight 965, Cali, Colombia, on Dec. 20, 1995

An effective briefing should include both nominal and non-nominal items, and should specifically invite feedback from the other crewmember. At Cali, the briefing should have included the previously mentioned approach conditions as well as the planned crossing altitudes and airspeeds over the Cali VOR for the expected instrument landing system (ILS) approach to Runway 01, and over the Tulua VOR for the possibility of a VOR DME [distance-measuring equipment] approach to Runway 19. The VOR DME approach procedure and the aircraft’s approximate track are shown in Figure 1.

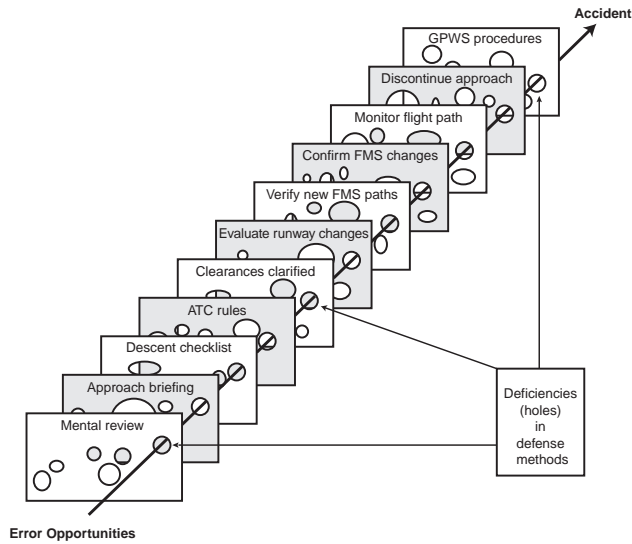
CFIT Defenses

These strategies are defenses against a potential CFIT accident. Figure 3 (page 19), which is adapted from an accident-causation model developed by James Reason, illustrates these defenses. These defenses, however, are not perfect and may contain some deficiencies — shown as holes in Figure 3. For this reason, it is important for airlines to improve continually each of these defenses through training. This action will reduce the deficiencies and begin to close the holes.
