Helicopter Downed in North Sea after Lightning Strike Exceeds Lightning-protection System Capabilities

A tail-rotor imbalance was caused by lightning damage to one of the carbon-composite tail-rotor blades. The resulting vibrations induced a dynamic response in the tailboom until the tail rotor and the tail-rotor gearbox separated from the aircraft.

On Jan. 19, 1995, a British-registered Aérospatiale (now Eurocopter) AS 332L Super Puma (Tiger), operated by Bristow Helicopters Ltd., was on a charter flight, ferrying 16 maintenance engineers from Aberdeen, Scotland, to the Brae "A" oil-rig platform in the North Sea.

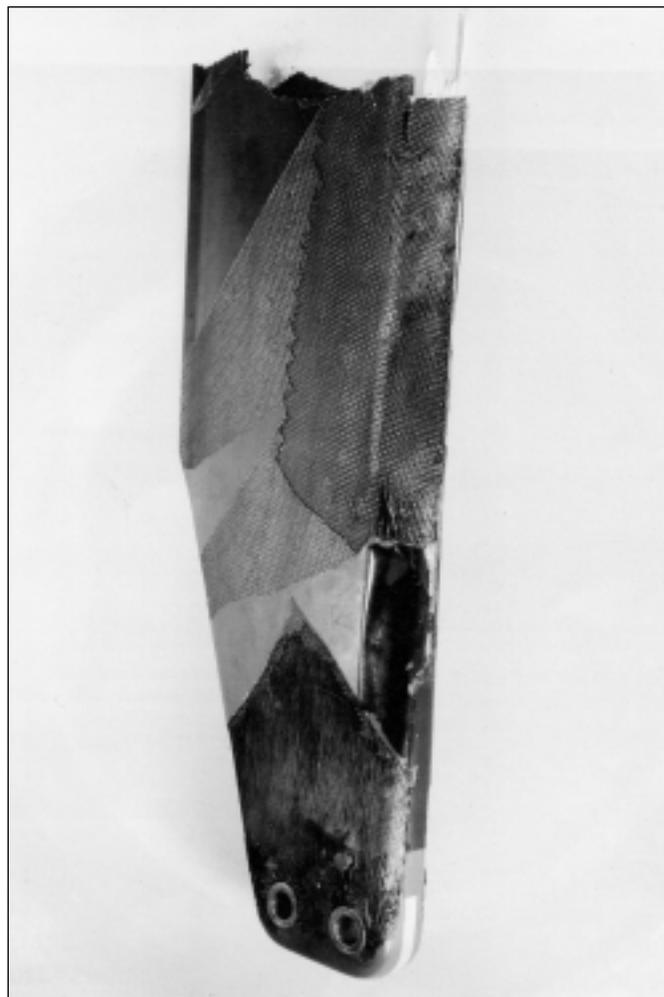
Detailed examination of the wreckage showed that two of the four main-rotor blades suffered lightning damage but continued to operate satisfactorily. Four of the five tail-rotor blades were damaged in a manner "consistent with the effect of the blades striking the pylon after the gearbox had separated," said the report. Significant lightning damage was evident on the fifth tail-rotor blade. Each tail-rotor blade is marked with a different color for identification. The report said that the white blade "suffered marked delamination of its composite skins and associated thermal damage of its root areas, together with loss of its antierosion shield, brass conducting strip and failure of the braided bonding strap and its attachment lug to the blade bolt [photo, top right]. ...

The damaged inboard (left) side of the white tail-rotor blade shows thermal delamination of the root area and general delamination outboard, including delamination of the leading edge from which the antierosion shield detached. (Photo: U.K. Air Accidents Investigation Branch)

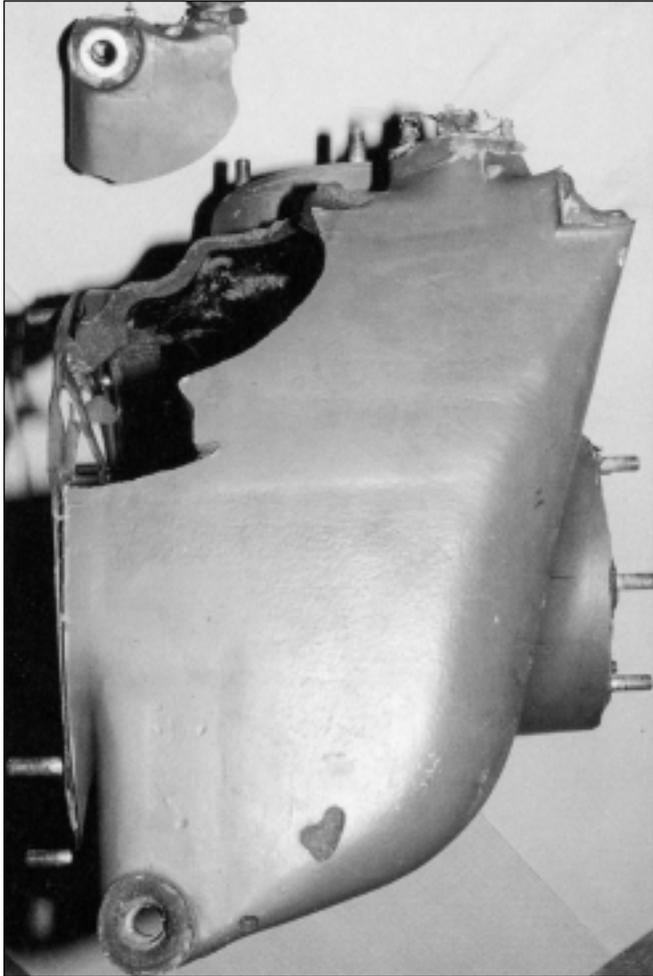
"Examination of the tail-rotor gearbox/pylon area confirmed that the gearbox had separated as a result of failure of the magnesium alloy gearbox casing at, or close to, the lower attachment points, in addition to failure of the upper attachment bolt [photo, page 4]."

Failure of lower gearbox attachments was caused by excessive vibration and led to separation of the tail-rotor gearbox from the tailboom. (Photo: U.K. Air Accidents Investigation Branch)

“Examination of the fractured bolt from the upper attachment of the gearbox revealed conclusive evidence that the bolt had been slack at the time of its failure, having rotated [while] under cyclic loading and having then failed due to a cyclic bending load,” said the report. “Examination of another AS 332L aircraft confirmed that the wire-locking of the three attachment bolts was of a very light gauge, unlikely to provide an effective restraint to rotation under excessive vibratory loads. ...

“The failure of the locking wire attached to the upper attachment-bolt head and consequent loosening of this bolt, as a result of the cyclic forces induced by the tail-rotor out-of-balance condition, increased the loading on the two lower mounting lugs both by load transfer and by altering the natural frequency of the tailboom–pylon assembly

Eurocopter responded: “*The analyses carried out subsequent to the [Jan. 19, 1995] accident have led us to design a modification which improves the strength of the gearbox on the tailboom. This modification, ... was approved on April 14, 1997, and proposes the installation of a bolt made from a new material and an optimized tightening torque load. This modification will be presented to our customers by Service Bulletin no. 64.00.24, classified ‘Recommended’*”;

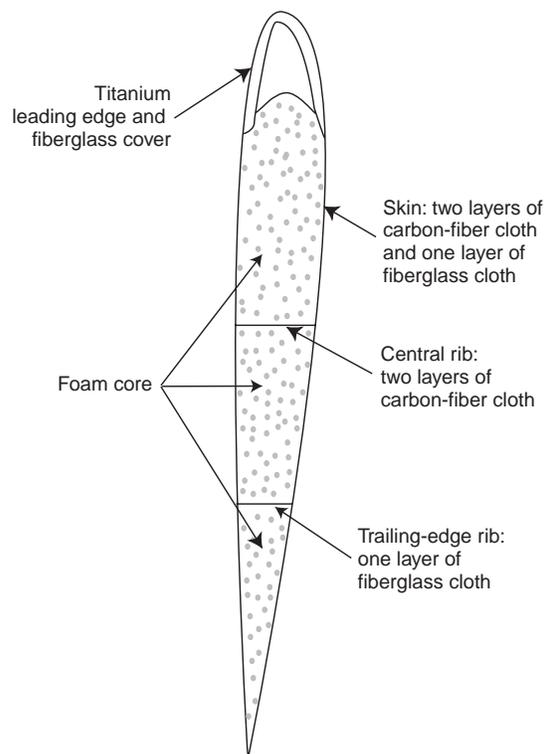
Figure 1

Although the tail-rotor blades on the accident aircraft were constructed using carbon-fiber materials, they differed from the original design on the AS 332L. The tail-rotor blades on the accident aircraft were constructed of a skin combining one layer of fiberglass and two layers of carbon-fiber cloth over a foam core (Figure 1). The modified design was used on all AS 332s flown by U.K.-based North Sea operators, as a remedy for poor foreign object damage-resistance characteristics of the original CFRP blades.

Composite Tail-rotor Blade on Accident Aérospatiale (Eurocopter) AS 332L

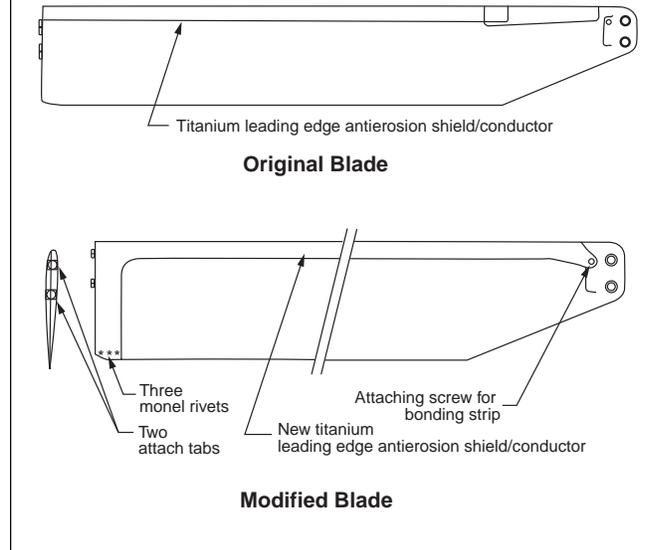
Figure 2

Original and Modified Tail-rotor Blades, Aérospatiale (Eurocopter) AS 332L

These new blades incorporated a titanium antierosion shield/conductor that extends inboard to the blade root and outboard to the blade-tip area (Figure 2). The titanium shield is riveted to the blade tip to provide positive retention if debonding occurs as a result of a lightning strike.

The report said, “This modified blade also included a fiberglass layer around the leading edge, i.e., underlying the erosion shield, and a new braided bonding strap between the root earthing bolt and hub.”
