## Unanticipated Right Yaw At Low Speeds

## HELICOPTER SAFETY

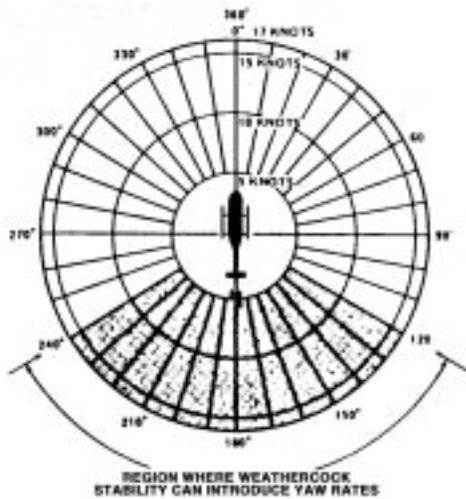
Winds within this region will attempt to weathervane the nose of the aircraft into the relative wind. This characteristic comes from the fuselage and vertical fin. The helicopter will make an uncommanded turn either to the right or left, depending upon the exact wind direction, unless a resisting pedal input is made. If a yaw rate has been established in either direction, it will be accelerated in the same direction when the relative winds are from 120 to 240 degrees (shaded area in Figure 1, see page 2) unless corrective pedal action is made. The importance of timely corrective action by the pilot to prevent high yaw rates from occurring cannot be overstressed.

**Figure 1. Weathercock Stability**

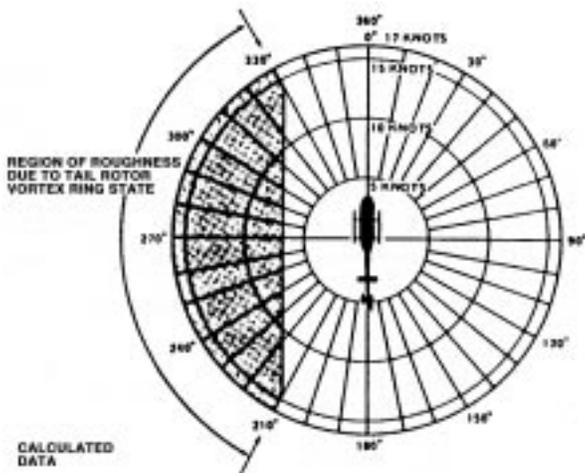
Winds within this region (Figure 2) will result in the development of the vortex ring state of the tail rotor. The vortex ring state causes tail rotor thrust variations, which results in yaw rates. Since these tail rotor thrust variations do not have a specific period, the pilot must make corrective pedal inputs as the changes in yaw acceleration are recognized.

**Figure 2. Tail Rotor Vortex Ring State**

The resulting high pedal workload in tail rotor vortex ring state is well known, and helicopters are operated routinely in this region. This characteristic presents no significant problem unless corrective action is not timely. If a right yaw rate is allowed to build, the helicopter can rotate into the wind azi-

Pilot workload during vortex ring state will be high; therefore, the pilot must concentrate fully on flying the aircraft and not allow a right yaw rate to build.

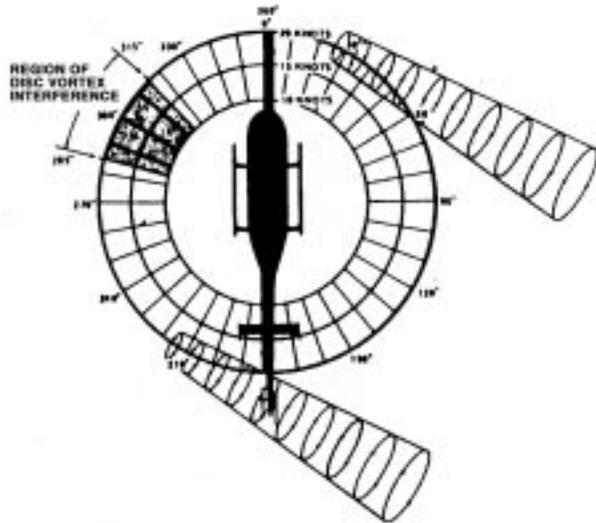
Winds within this region can cause the main rotor vortex to be directed onto the tail rotor. The effect of this main rotor disc vortex is to change the tail rotor angle of attack. Initially, as the tail rotor comes into the area of the main rotor disc vortex during a right turn, the angle of attack of the tail rotor is increased. This increase in angle of attack requires the pilot to add right pedal (reduce thrust) to maintain the same rate of turn.

As the main rotor vortex passes the tail rotor, the tail rotor angle of attack is reduced. The reduction in angle of attack causes a reduction in thrust, and a right yaw acceleration begins. This acceleration can be surprising, since the pilot was previously adding right pedal to maintain the right turn rate.

Analysis of flight test data during this time verifies that the tail rotor does not stall. The helicopter will exhibit a tendency to make a sudden, uncommanded right yaw which, if uncorrected, will develop into a high right turn rate. When operating in this region, the pilot must anticipate the need for sudden left pedal inputs.

**Figure 3. Main Rotor Disc Vortex Interference**
