Rethinking Overrun Protection

Midway International Airport's December 2005 accident makes airport operators reconsider installing the latest engineered materials arresting system.

BY WAYNE ROSENKRANS

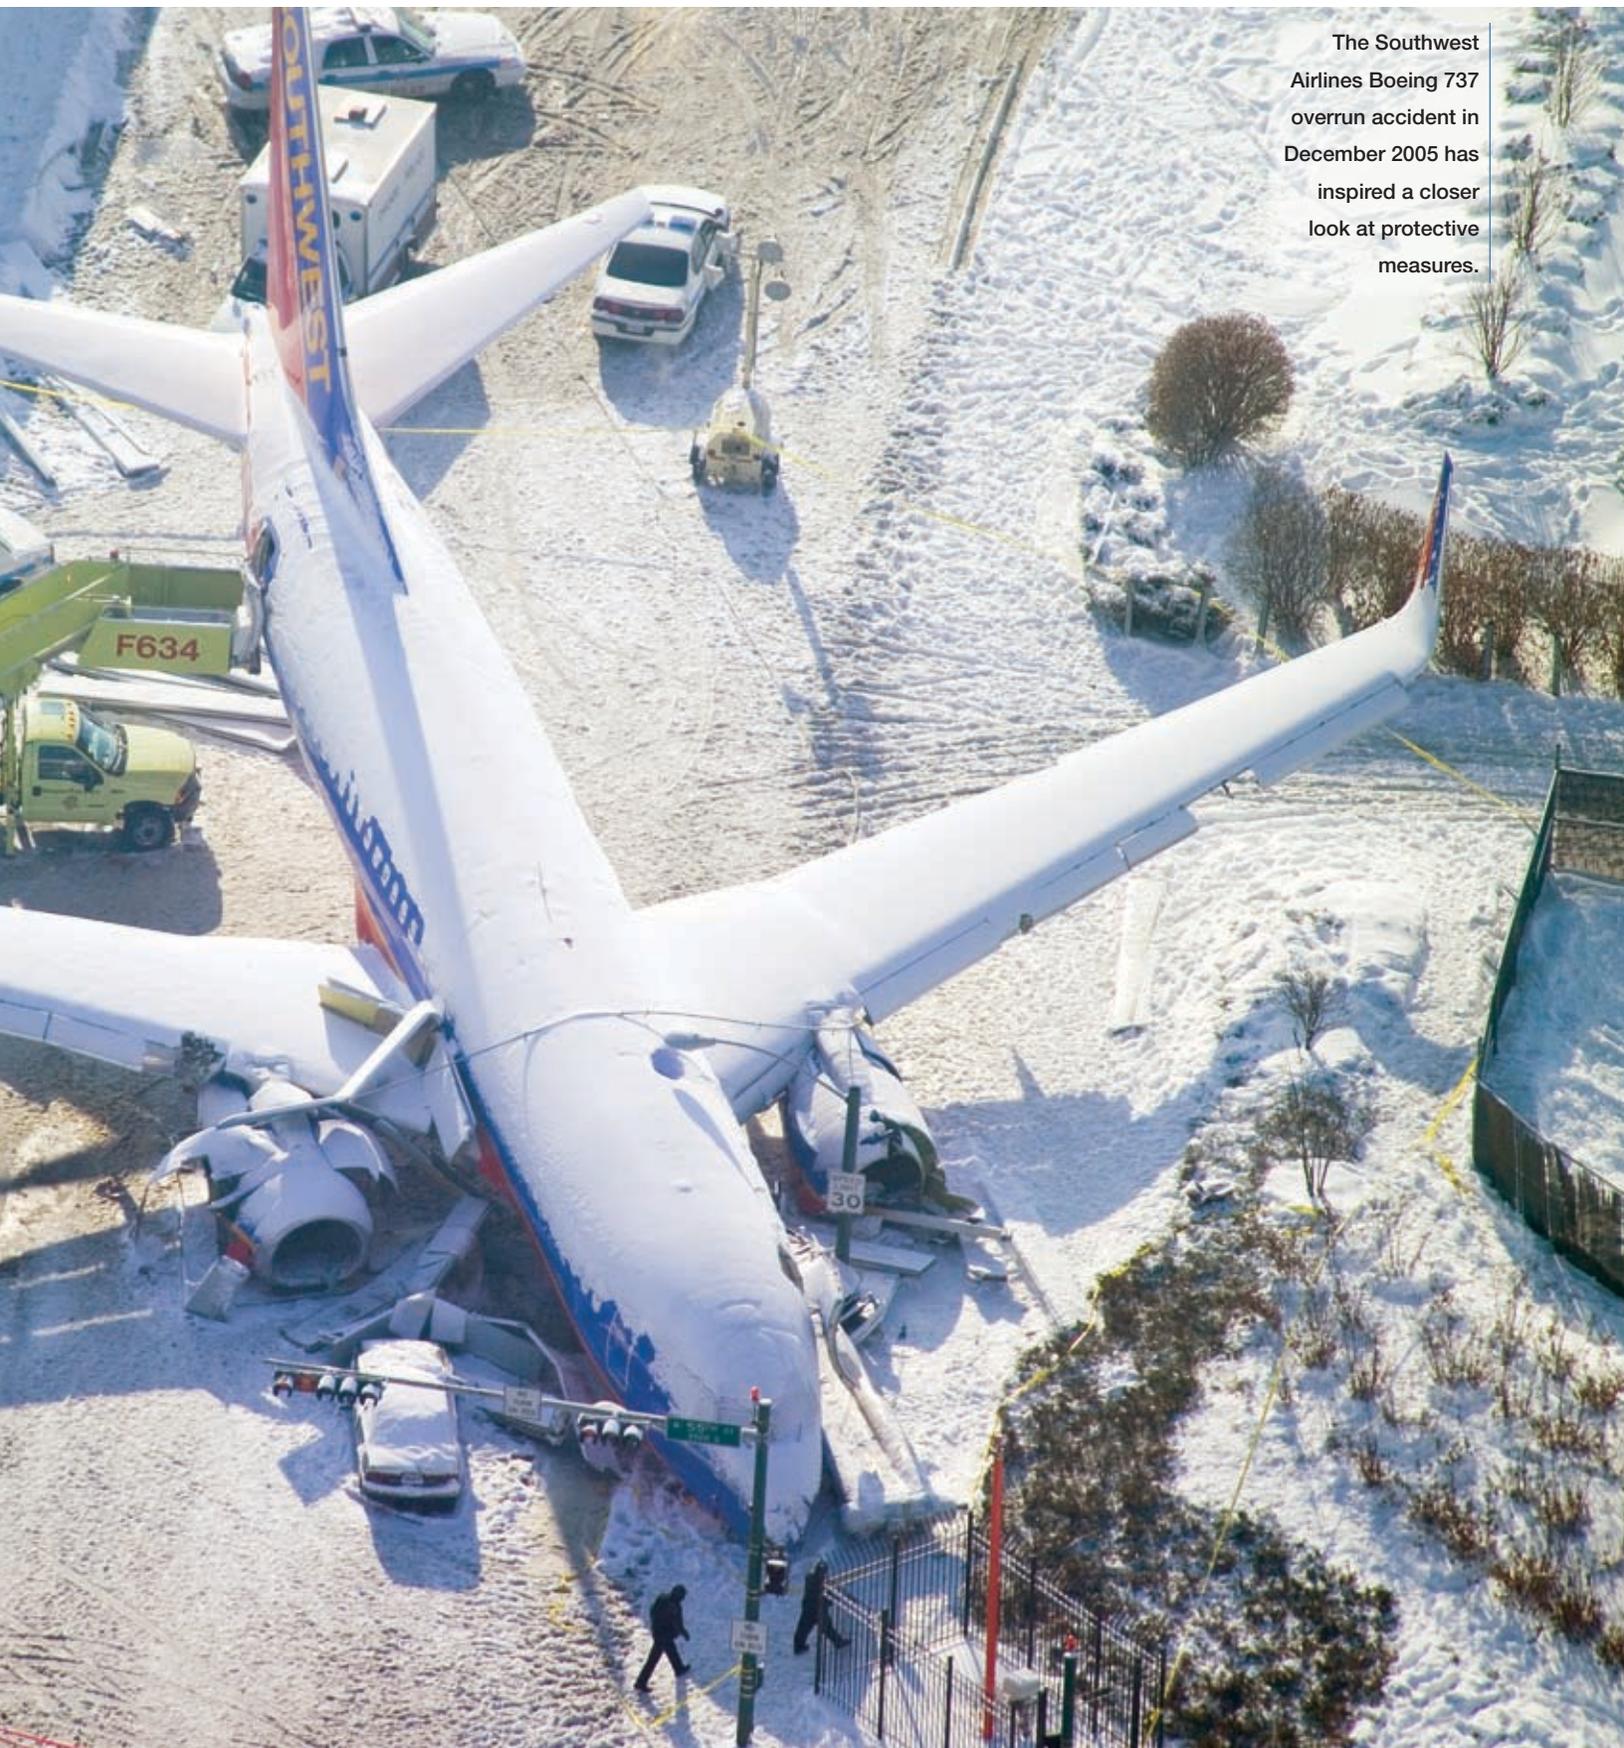
The Southwest Airlines Boeing 737 overrun accident in December 2005 has inspired a closer look at protective measures.

The process many airport operators used to conclude EMAS would not be practical at their facilities captured attention at a U.S. National Transportation Safety Board (NTSB) June 2006 public hearing on the Dec. 8, 2005, overrun accident at Midway International Airport in Chicago. Southwest Airlines Flight 1248, a Boeing 737-700, landed on snow-contaminated Runway 31C, rolled past the end of the runway at a groundspeed of about 50 kt, and knocked down a blast fence and a perimeter fence to

encounter motor vehicle traffic on an off-airport street, NTSB said. A six-year-old boy was killed in a car hit by the 737.

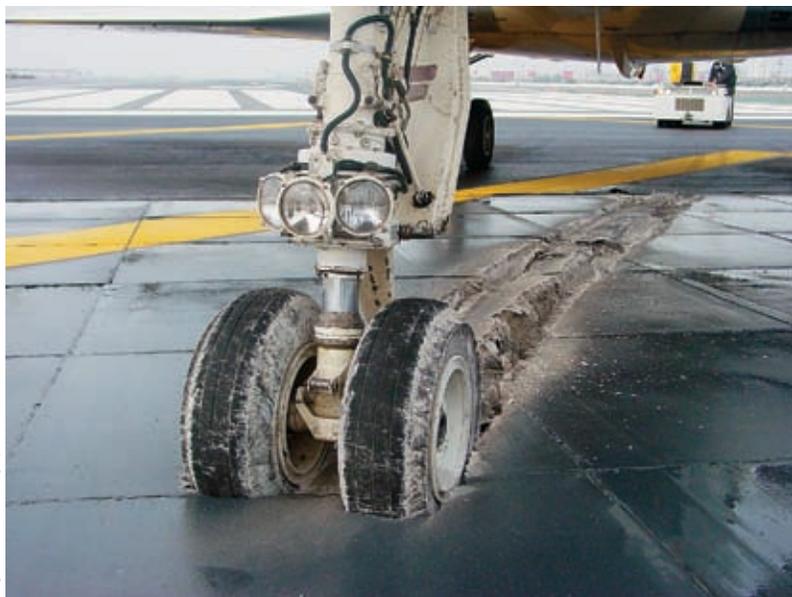
Loads generated by tires crushing the arrestor-bed material — not friction — safely decelerate the airplane.

Each generation of EMAS in service — developed since 1986 by Engineered Arresting Systems Corp. (ESCO), FAA and the Port Authority of New York and New Jersey — has provided an elevated arrestor bed, composed of prefabricated blocks of aerated portland cement, beyond the departure end of a runway. “First and foremost, we are trying to maximize deceleration within the limits of the landing gear,” said G. Kent Thompson, vice president of airport engineering and sales for ESCO, during the hearing. “As tires crush the material, it creates a tire-material interface at the leading edge of the wheel [that] provides a decelerative load, a drag load, to slow the airplane down. That load is transmitted

up through the landing gear and the support structure for the landing gear to decelerate and stop the aircraft. A very important point is that EMAS does not rely on friction.”

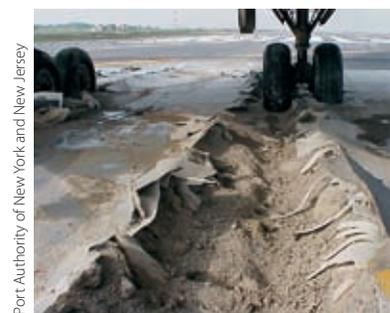
An arrestor bed at John F. Kennedy International Airport was crushed by a McDonnell Douglas MD-11 in 2003.

- In May 2003, a McDonnell Douglas MD-11 operated by Gemini Air Cargo with a weight of about 470,000 lb (213,191 kg) was safely arrested during a low-speed overrun on Runway 4R at Kennedy. The aircraft was extracted from the arrestor bed within a few hours.
- In the January 2005 overrun on Runway 4R at Kennedy, a Polar Air Express cargo 747 with a weight of about 610,000 lb (276,694 kg) and an exit speed greater than 70 kt was stopped safely by the arrestor bed.

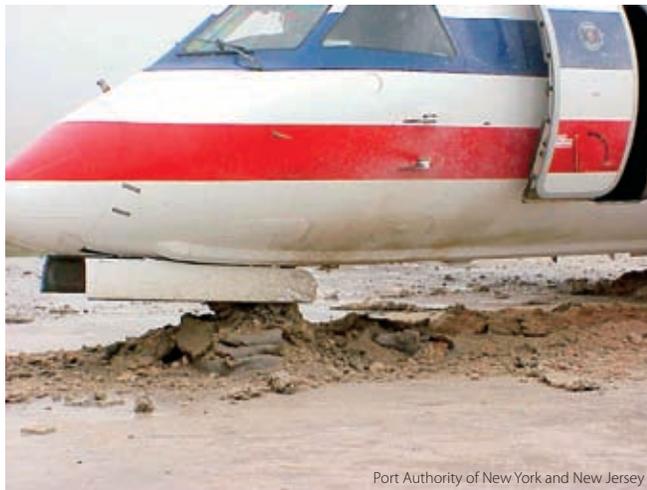
A Saab 340B arrestment occurred in 1999 at John F. Kennedy International Airport.

- In May 1999, American Eagle Flight 4925, a Saab 340B commuter aircraft weighing about 22,000 lbs (9,979 kg) with 30 occupants, overran the departure end of Runway 4R at Kennedy with an estimated runway-exit speed of 75 kt. NTSB said that the airplane traveled approximately 248 ft (76 m) across the arrestor bed before it came

to a stop. "Computer modeling indicates that in the absence of the EMAS, an exit speed of only 70 kt would have resulted in the aircraft reaching Thurston Basin [a waterway approximately 600 ft (183 m) beyond the end of the runway]," FAA said. "The aircraft ... was brought to a halt with only minor damage. The only injury occurred during the evacuation of the aircraft when a passenger twisted an ankle." ESCO said that this airplane was extracted from the EMAS within four hours by removing crushed blocks and pulling the airplane backwards with a tow vehicle attached to each main gear. The runway reopened without delay, and repairs to the arrestor bed were completed in 15 days.
