MAY-JUNE 1998

D I G E S T

Boeing 757 CFIT Accident at Cali, Colombia, Becomes Focus of Lessons Learned

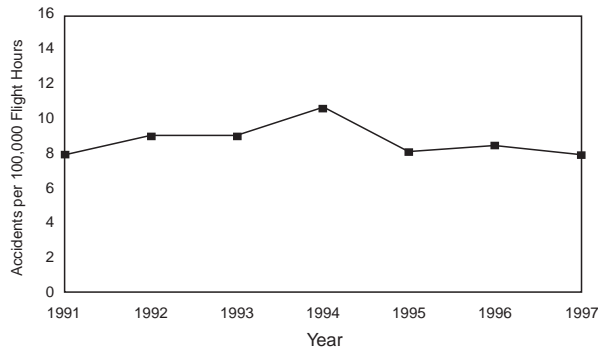
Figure 1

During the 1991–1997 period, the rotorcraft accident rate ranged as high as 10.62 accidents per 100,000 flight hours in 1994 (Figure 1 and Table 1), when the number of accidents also peaked at 207.

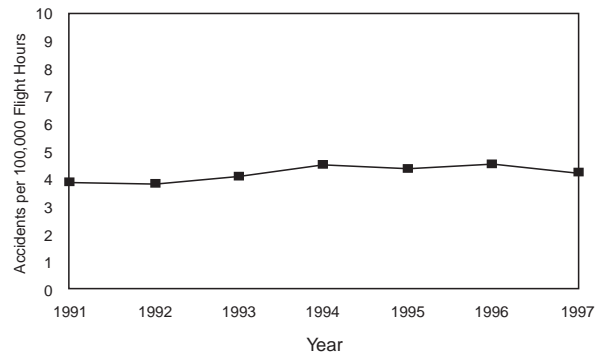
Figure 2

The 1997 air-taxi-accident rate was 4.14 per 100,000 flight hours, the lowest since 1993 (Figure 2 and Table 3). The air-taxi-accident rate in the 1991–1997 period ranged from a low of 3.80 in 1992 to 4.47 in 1994. There were 82 air-taxi accidents in 1997, compared with 89 in 1996.
