Helicopter Downed in North Sea after Lightning Strike Exceeds Lightning-protection System Capabilities

A tail-rotor imbalance was caused by lightning damage to one of the carbon-composite tail-rotor blades. The resulting vibrations induced a dynamic response in the tailboom until the tail rotor and the tail-rotor gearbox separated from the aircraft.

On Jan. 19, 1995, a British-registered Aérospatiale (now Eurocopter) AS 332L Super Puma (Tiger), operated by Bristow Helicopters Ltd., was on a charter flight, ferrying 16 maintenance engineers from Aberdeen, Scotland, to the Brae "A" oil-rig platform in the North Sea.

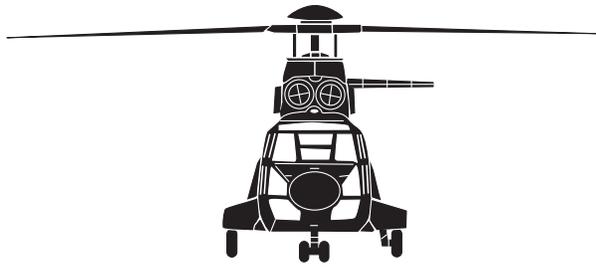
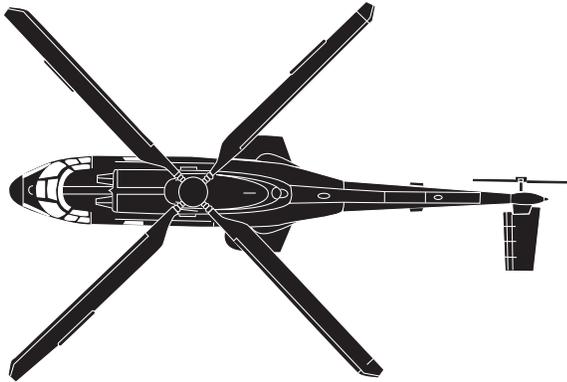
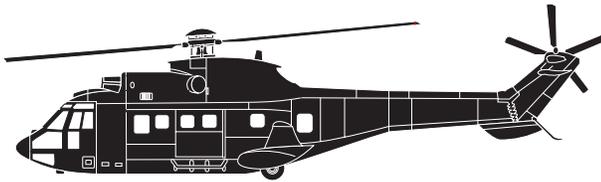
Detailed examination of the wreckage showed that two of the four main-rotor blades suffered lightning damage but continued to operate satisfactorily. Four of the five tail-rotor blades were damaged in a manner "consistent with the effect of the blades striking the pylon after the gearbox had separated," said the report. Significant lightning damage was evident on the fifth tail-rotor blade. Each tail-rotor blade is marked with a different color for identification. The report said that the white blade "suffered marked delamination of its composite skins and associated thermal damage of its root areas, together with loss of its antierosion shield, brass conducting strip and failure of the braided bonding strap and its attachment lug to the blade bolt [photo, top right]. ...

The damaged inboard (left) side of the white tail-rotor blade shows thermal delamination of the root area and general delamination outboard, including delamination of the leading edge from which the antierosion shield detached. (Photo: U.K. Air Accidents Investigation Branch)
