Walking INTO

Accidents involving human contact with propellers and rotor blades persist, despite safety efforts to prevent them.

BY CLARENCE E. RASH

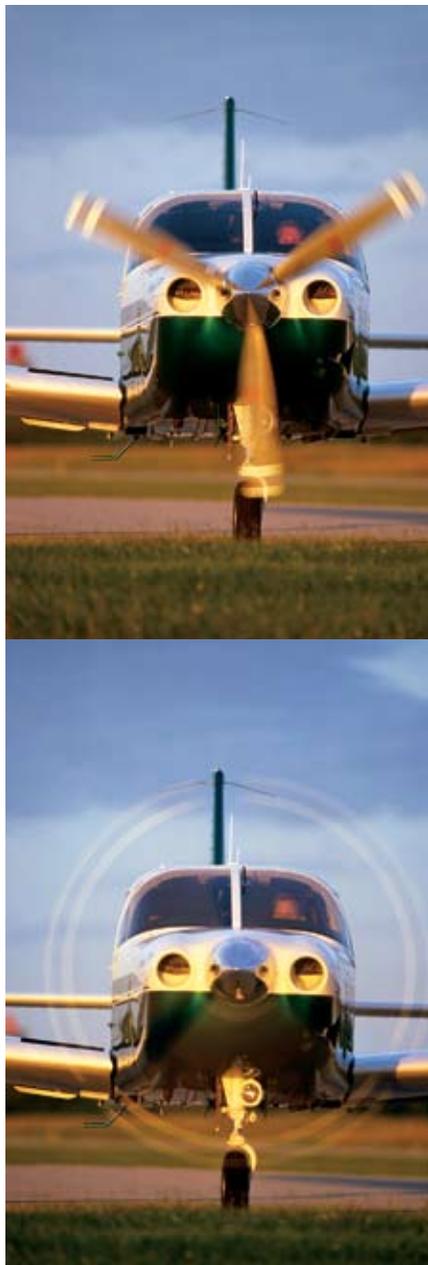
Paint bands on propellers and rotor blades become visible concentric circles when in motion, helping ground personnel identify and avoid their dangerous arcs.

For decades, manufacturers and operators have used various methods to help prevent injuries caused by rotor blades and propellers. One involves the use of different paint schemes to increase the conspicuity of rotating rotor blades and propellers. This strategy was suggested as early as 1954, when the U.S. Navy began using a black, red and white pattern on propeller blades; when the propeller is in motion, this pattern results in the visual effect of concentric circles.¹²

Today, for example, many airplanes and helicopters have stripes of high visibility paint on their propellers and rotor blades, and many helicopter tail rotors still have a black-and-white paint scheme — which was designated as “most conspicuous” in a 1978 report by CAMI.¹³ Among the most recent recommendations is one from Defence Research and Development Canada, which calls for two brightly colored stripes, discontinuous from one blade to the next, on each of the four main rotor blades of the CH-146 Griffon combat support helicopter. This configuration is designed to produce a circular flickering effect as the blades rotate.¹⁴
