# AeroSafety WORLD

July 2008 Vol 3 Issue 7

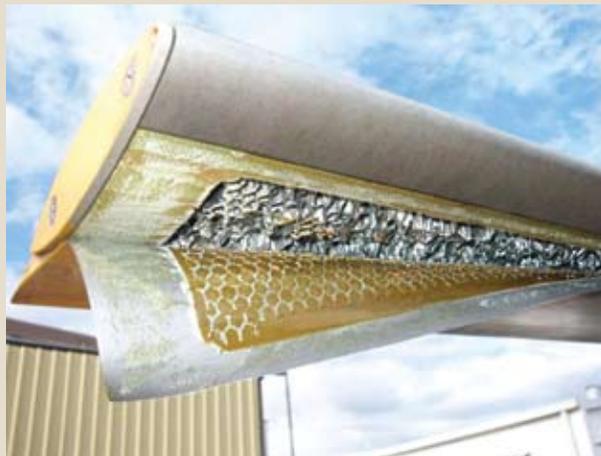
Some hot, humid operating environments may be contributing to the degradation of adhesive bond joints in Robinson Helicopter rotor blades, and new testing methods are required to ensure the detection of separation at bond joints, the U.S. National Transportation Safety Board (NTSB) says.

The NTSB said that examination of rotor blades from helicopters involved in several recent accidents indicates that “debonding (separation) of the rotor blade skin ... led to fracture of the rotor blade.”

Typically, the inspection of adhesive joints on Robinson main rotor blades involves the tap test method in which the surface of an adhesive joint is tapped with a small hammer or a coin while the person conducting the inspection listens for changes in pitch that indicate defects.

“Adhesive bond joints are likely to degrade with time when subjected to harsh environments, such as the high humidity and high temperatures typically found at or near the sea, and ... tap

testing of the main rotor blades is not adequate for consistently detecting debond at the skin-to-spar and skin-to-tip cap bond areas,” the NTSB said. “Consequently, separation at bond joints could remain undetected and lead to in-flight separation of the main rotor blade skin and possible loss of control.”

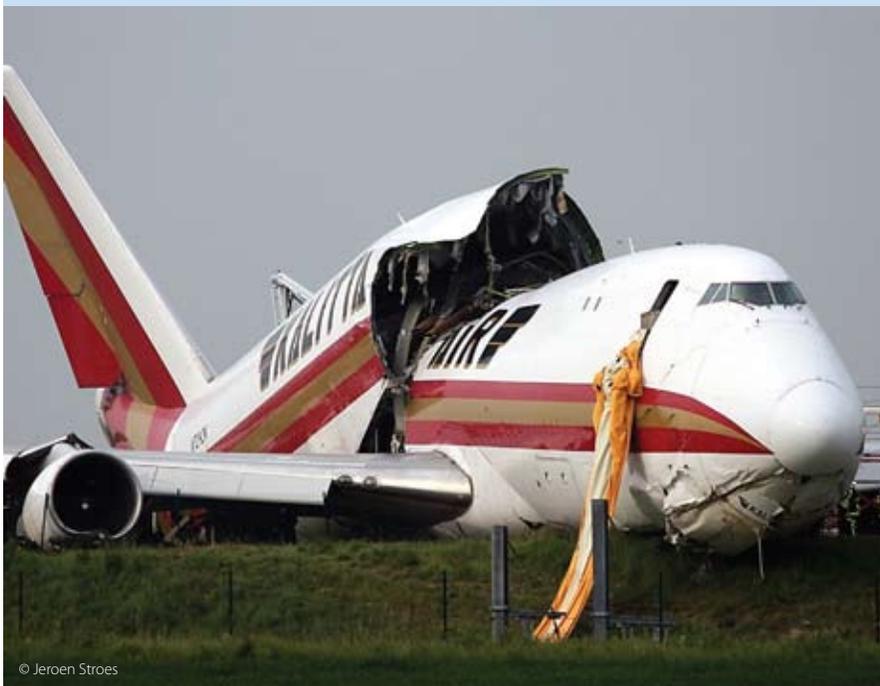
*Belgian accident investigators are searching for the cause of the May 25 crash of this Kalitta 747-200 during takeoff from Brussels for a flight to Bahrain. Witnesses reported hearing a loud bang just before the airplane ran off the runway and broke apart. None of the four people in the cargo airplane was injured.*

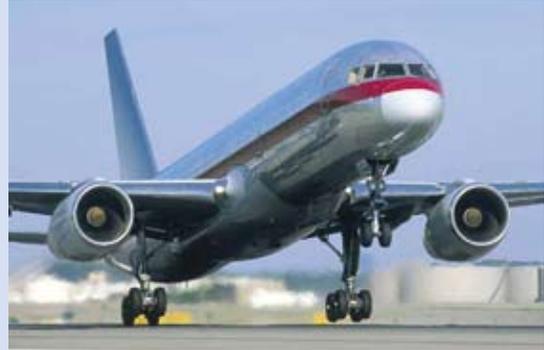
The NTSB, noting that Boeing considers spacers critical in extending the fatigue life of the support clips, said that the cracked clips could have resulted from incorrect clip orientation, the age of the clips, the absence of spacers or a combination of these three issues.

The NTSB said it is “concerned that there may be other [757s] with cracked and/or improperly oriented clips or lack of spacers, which could lead to support clip failure and a wing fixed trailing edge panel separation. A wing fixed trailing edge panel that separates from the aircraft in flight could impact the tail of the airplane, resulting in the potential loss

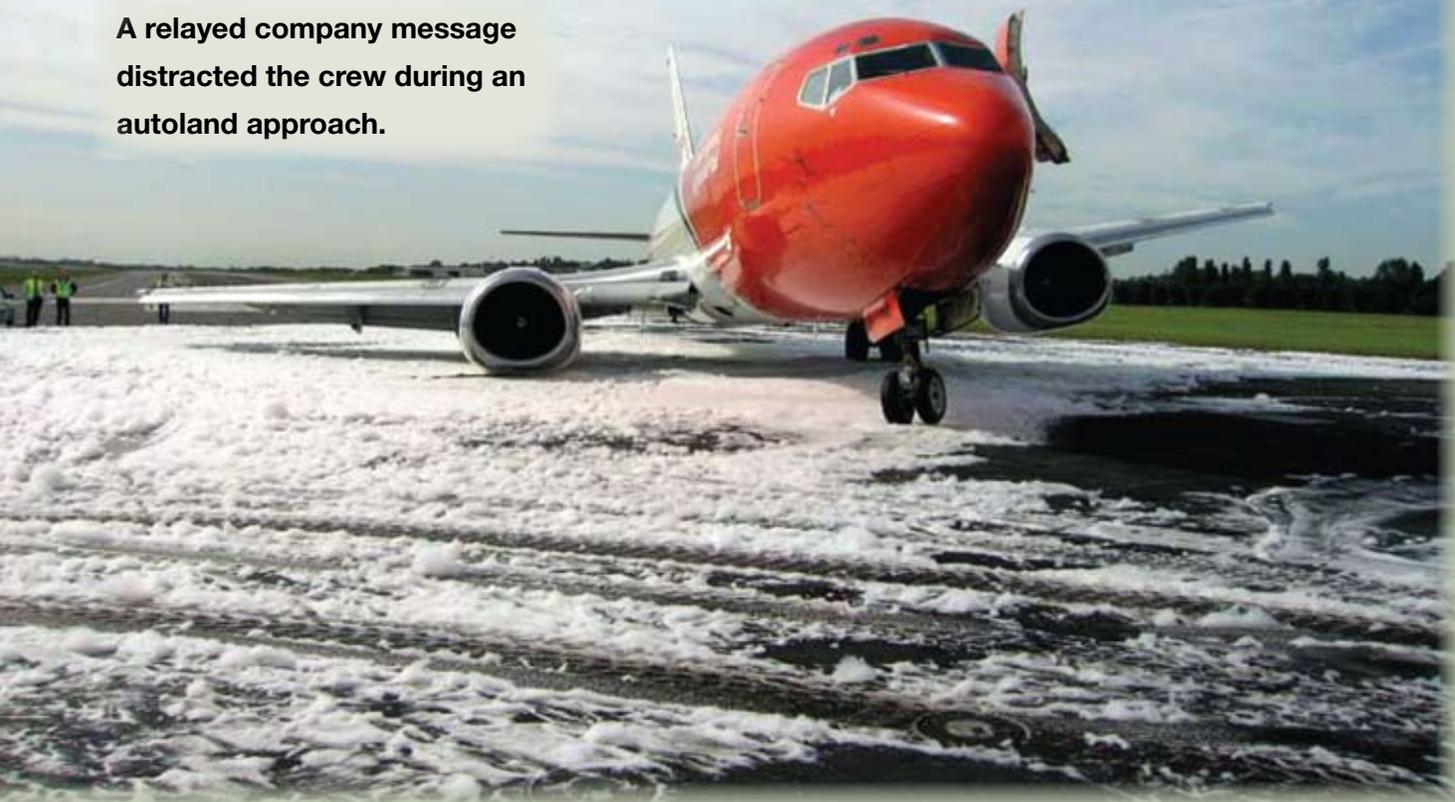
The Boeing 737-300 freighter was about 500 ft above ground level (AGL) during a Category IIIA approach to England's Nottingham East Midlands Airport when the flight crew was told by air traffic control (ATC) that the airline had instructed that they were "not to land here." The commander, the pilot flying, inadvertently pressed the autopilot-disengage button instead of the radio-transmit button on his control yoke to seek clarification of the message. The 737 deviated above the glideslope and left of course before sinking rapidly.

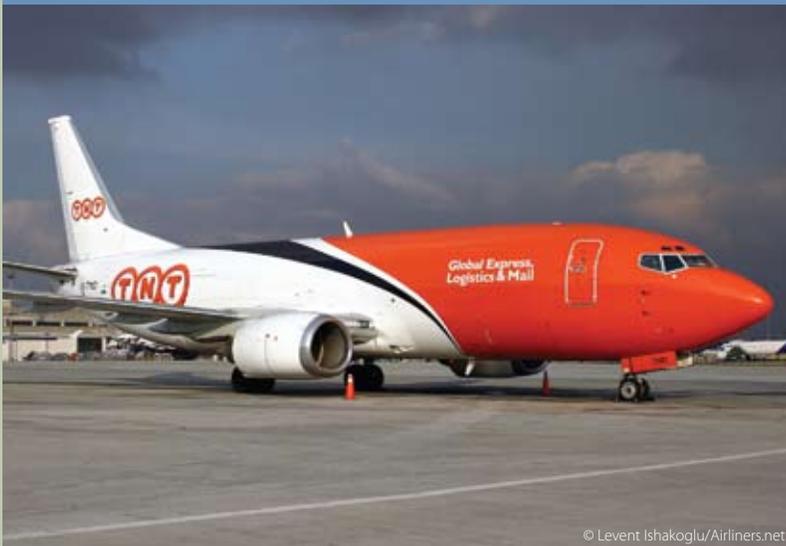
## Boeing 737-300

The 737 was designed to use many components and assemblies from the 727. Deliveries of the first production model, the 737-200, with Pratt & Whitney JT8D engines, began in 1967. The larger 737-300 was introduced in 1984 with CFM International CFM56 engines rated at 20,000 lb (9,072 kg) thrust.

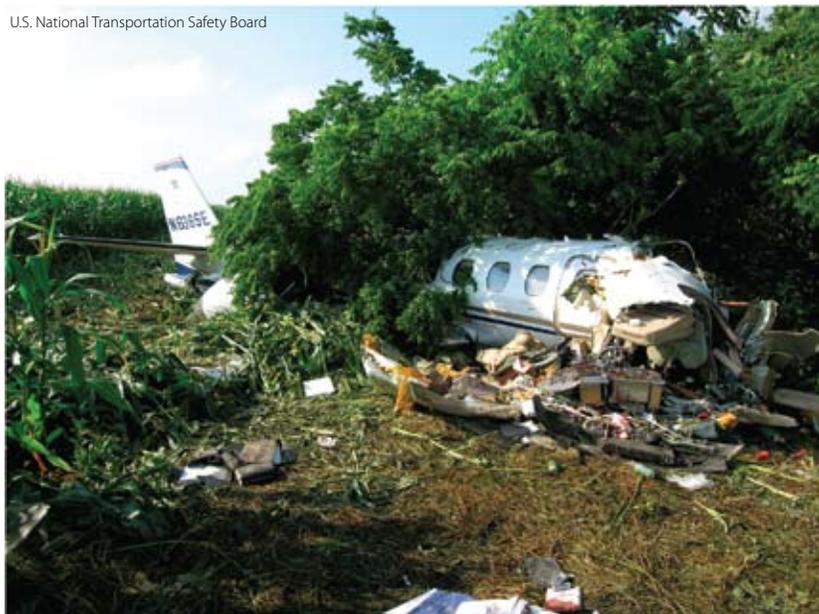
The cockpit burst on impact with a tree after the Citation overran the short runway at Cresco, Iowa. The accident report blamed ‘poor CRM.’

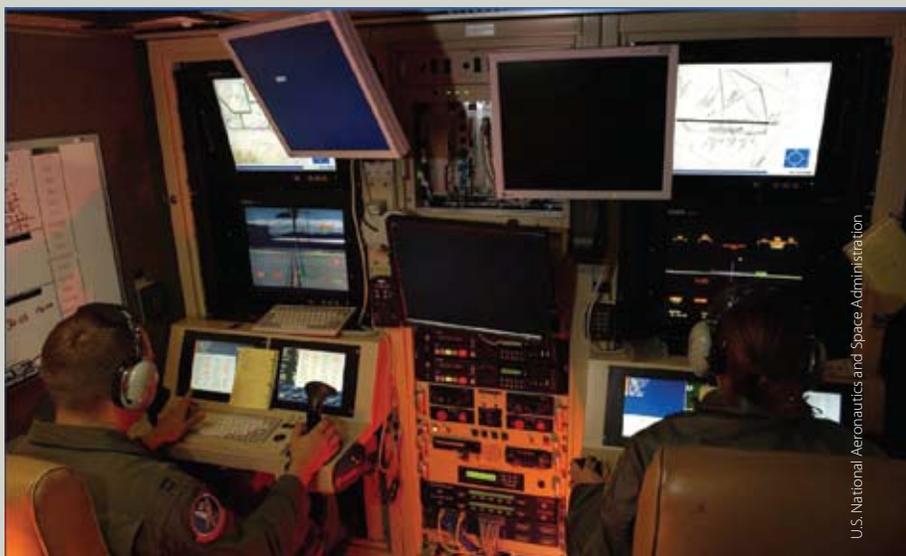
The ground control station for the Predator B, like other UAS, in time will become less aircraft-specific and somewhat more like a cockpit.
