Aviation Safety WORLD

FATAL CALCULATION

THE JOURNAL OF FLIGHT SAFETY FOUNDATION

OCTOBER 2006

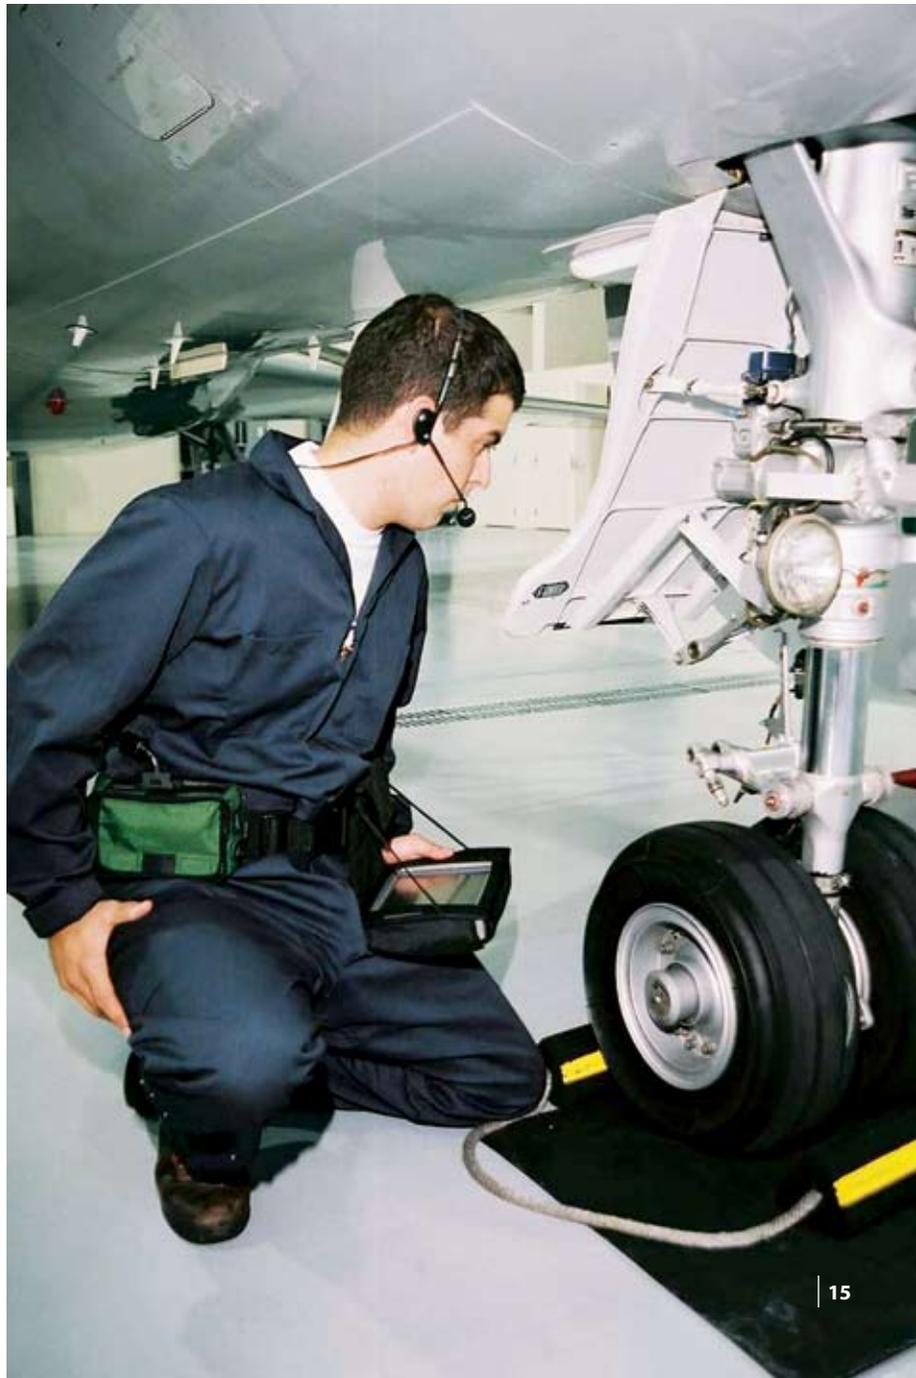
Some portable computers can be attached to the user’s clothing.

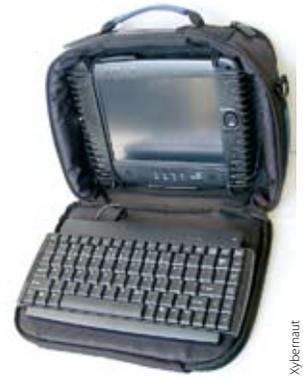
Some portable computer devices are touch-activated with a stylus or fingertips.

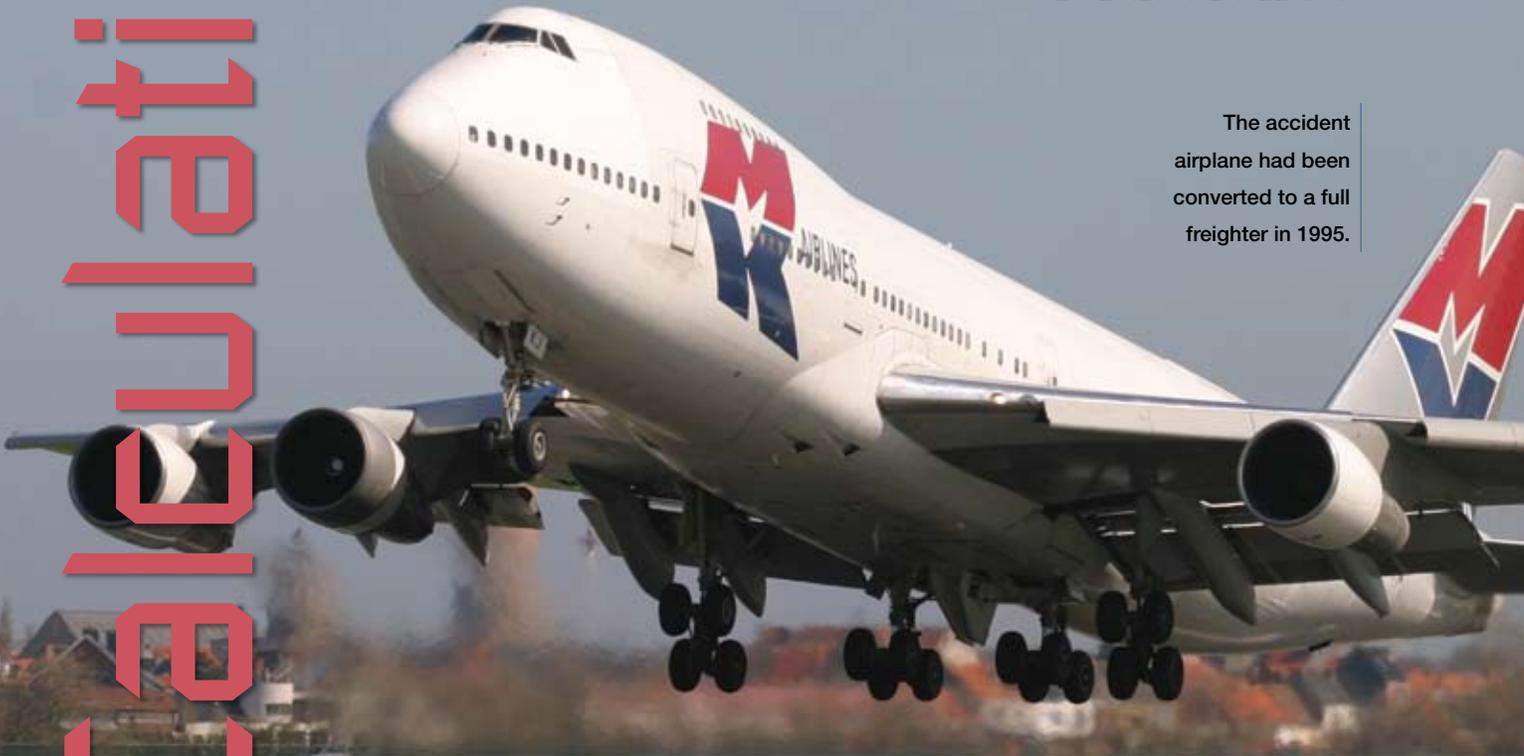
The accident airplane had been converted to a full freighter in 1995.

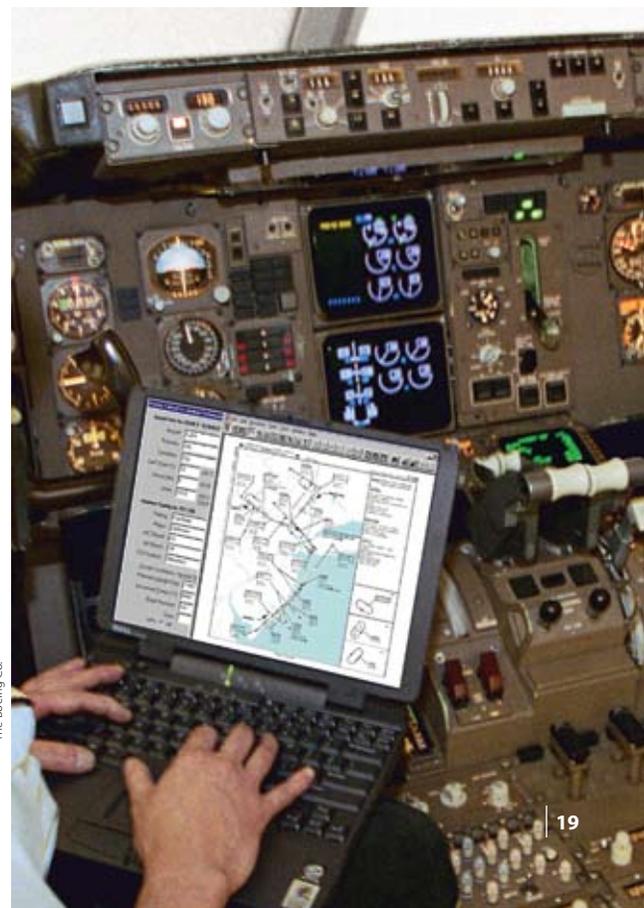
The Boeing Laptop Tool is used in calculating takeoff and landing performance data.
