# AeroSafety WORLD

PRECISION-LIKE APPROACHES  
USE EXISTING CAPABILITIES BETTER

# From Nonprecision to Precision-Like Approaches

## Second in a series focusing on the development and safety benefits of precision-like approaches, a project of the FSF International Advisory Committee.

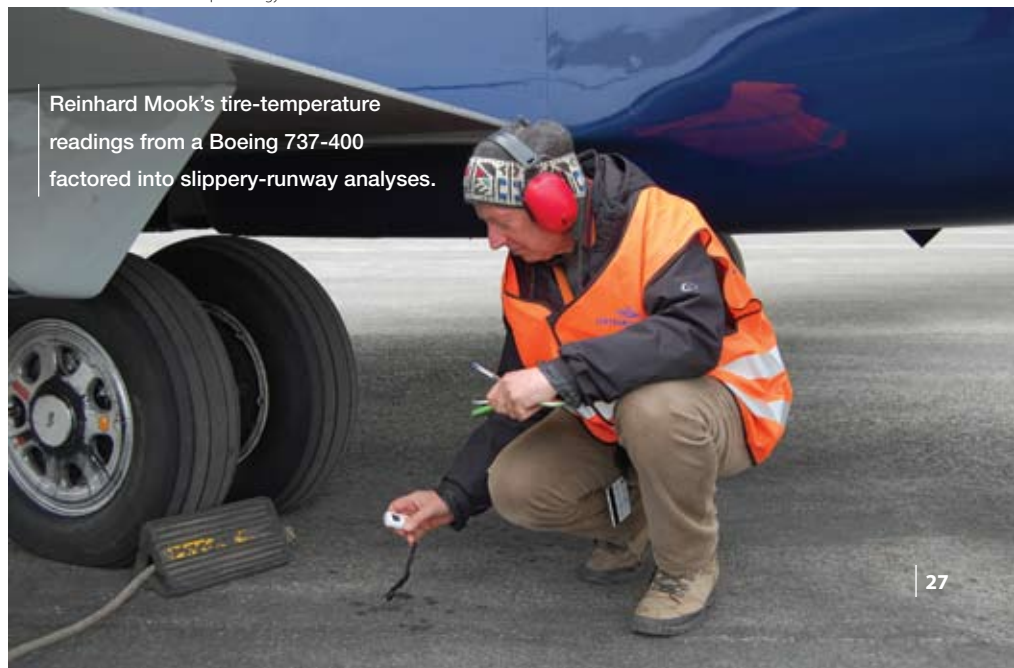
Reinhard Mook's tire-temperature readings from a Boeing 737-400 factored into slippery-runway analyses.

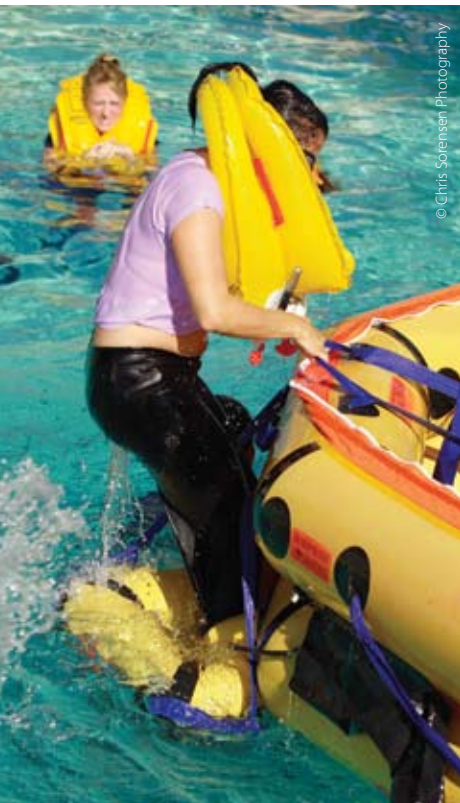
Confidence gained boarding a life raft from the water extends to other aspects of coping with a ditching.

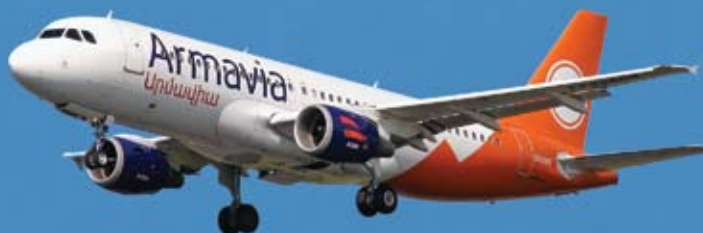
## Airbus A320

Development of the A320 began in 1984, and deliveries began in 1988. It is the first subsonic commercial airplane with major primary structures manufactured from composite materials, a "fly-by-wire" control system and sidestick manual controls.

The A320 accommodates two flight crewmembers and up to 180 passengers. The engines are either CFM International CFM56s or IAE V2500s. Fuel capacities are 23,859 liters (6,304 gal), standard, and 29,659 liters (7,836 gal), maximum optional.
