Air Ambulance Strikes Terrain After Takeoff in Fog

Visibility was less than 0.25 statute mile (0.40 kilometer) when the crew of the Sikorsky S-76A began the night repositioning flight. Less than two minutes after takeoff, the helicopter struck a tree-covered hillside.

At 2208 local time June 14, 1999, a Sikorsky S-76A helicopter being operated by Petroleum Helicopters Inc. (PHI) as an air ambulance for the University of Kentucky Medical Center (37KY) at Lexington, Kentucky, U.S., collided with terrain in instrument meteorological conditions (IMC) during departure from Jackson, Kentucky. The helicopter was destroyed, and all four people in the helicopter — two pilots and two medical crewmembers — were killed.

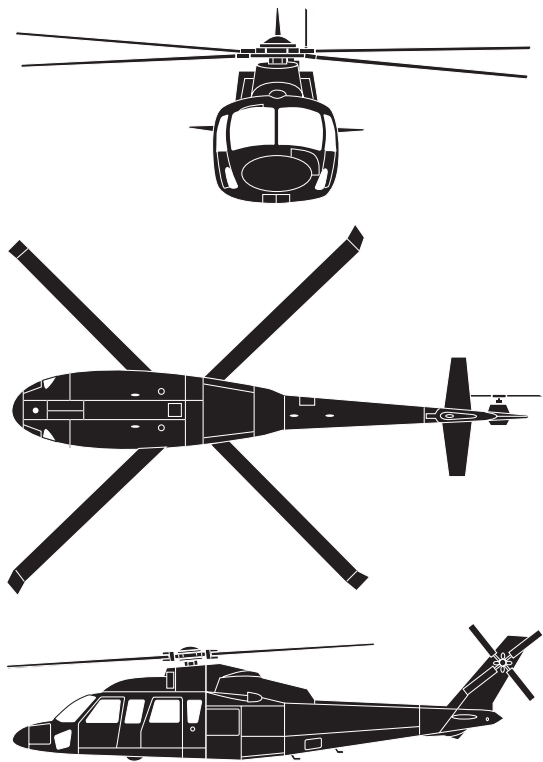
The Sikorsky S-76 first flew in 1977. The S-76A is configured to accommodate 12 passengers and two pilots. It has a maximum takeoff weight of 10,300 pounds (4,672 kilograms), a maximum cruising speed of 145 knots and a service ceiling of 15,000 feet. The S-76A has a maximum range of 404 nautical miles (748 kilometers) with 12 passengers, standard fuel and 30-minute reserves. The S-76A is powered by two Allison 250-C30 turboshaft engines, each rated at 650 shaft horsepower (485 kilowatts).♦
